UI Bulletin #162

Subject: Rear Chassis Electrical Harness attachments replacement upfit interface

Models Affected: Chevrolet Silverado, GMC Sierra 3100 Series HD Cab Chassis models only

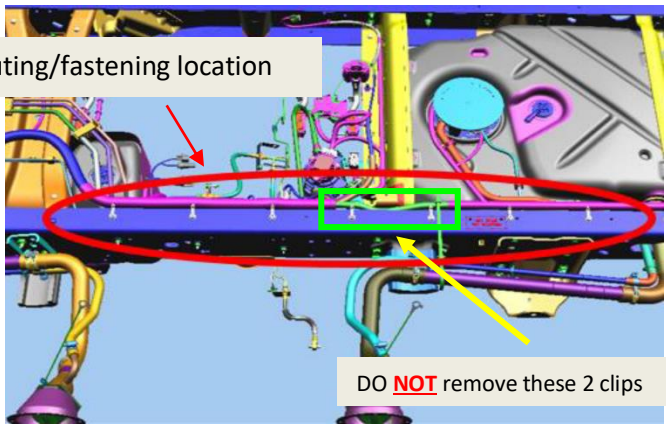
Figure 1

Some Chevrolet Silverado, GMC Sierra 3600 Series Cab Chassis upfits may require alternative rear chassis harness attachments. Wiring Harness `Service Access' could be compromised when mounting an upfit body. Upfit Body mounting provisions could lock in the OEM harness/attachments.

Upfit body mounting practices should allow for service of chassis wiring harness/attachments. For upfits that utilize semi-continuous `top of frame rail' contact, it is recommended that the rear electrical harness attachments be replaced with alternative `service accessible' components. The following will provide instructions for replacement of the OEM rear harness attachments if it is deemed necessary refer to figure 1.

1) Remove with wiring snips, **6** of the 8 factory black plastic harness clips in areas shown (see Fig. 1)
IMPORTANT: Do **NOT** remove the 2 factory plastic attachment clips **(green area)** located by the rear fuel tank lines.
